# ASSESSMENT OF WATER SUPPLY AND SANITATION INFRASTRUCTURES IN URBAN ENVIRONMENT OF CAMEROON AND PERSPECTIVES UNDER LOOMING CLIMATE CONDITIONS. CASE STUDY OF THE CITY OF KUMBA, MEME DIVISION, SOUTH WEST REGION OF CAMEROON

Global South Academic Conclave on WASH and Climate linkages

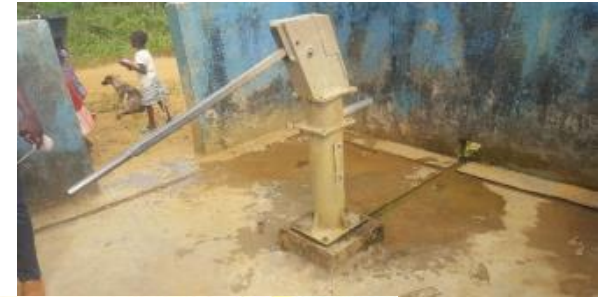
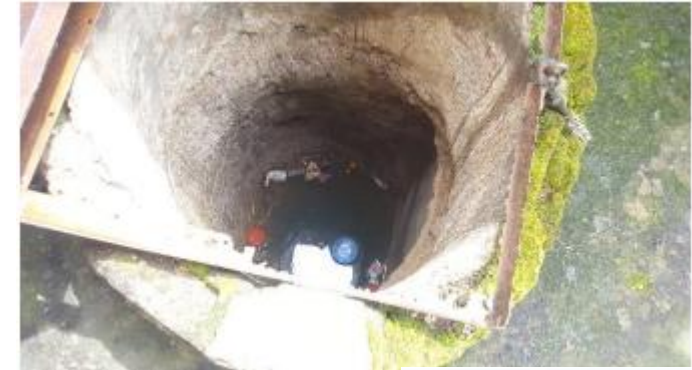
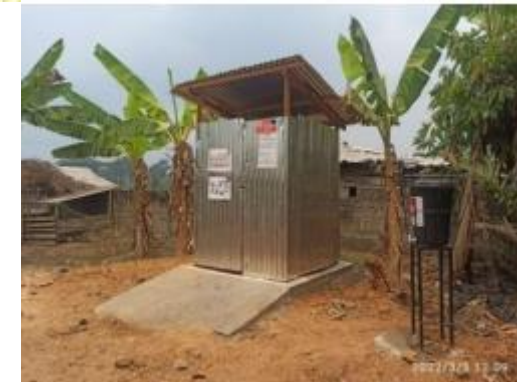
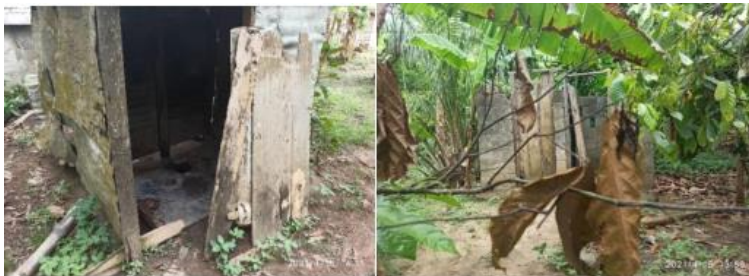
- ❑ There is also a pipe born water network from CAMWATER which supplies all the 3 municipalities of Kumba at households and public taps even though not effective.

- ❑ When there is no supply of water from CAMWATER the population relies on the boreholes, developed wells and developed springs for their drinking water and a proportion of the population relies on eater from unprotected wells and springs for drinking probably due to irregular supply from CAMWATER or the complete absence of any piped water networks within their communities.

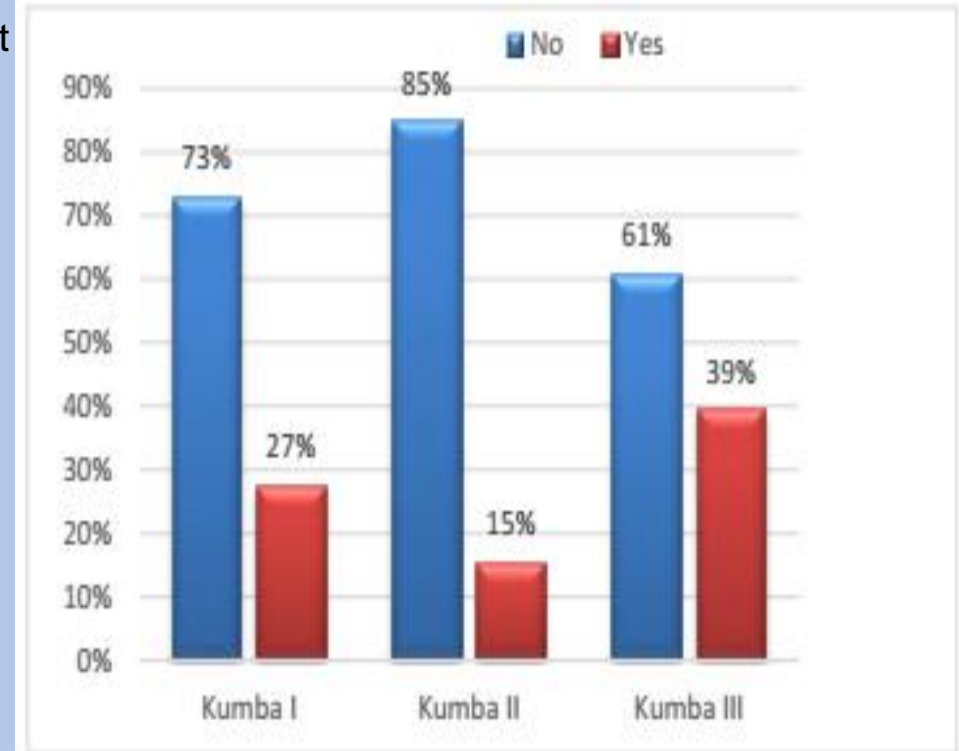
Availability of water management committee

- ❑ 73% of the water points in Kumba I did not have any water management committees,
- ❑ while 85% in Kumba II did not have the presence of any management committees and 61% in Kumba III also had the absence of any management committees.
- ❑ This explains the reason why most of the water points visited had major breakdowns and no major repair works were conducted in making the water points functional.
- ❑ The water points which had committees were mostly water points which were recently constructed or rehabilitated by some international humanitarian NGOs like NRC, IRC, Solidarite International.
